How did Herculaneum survive?

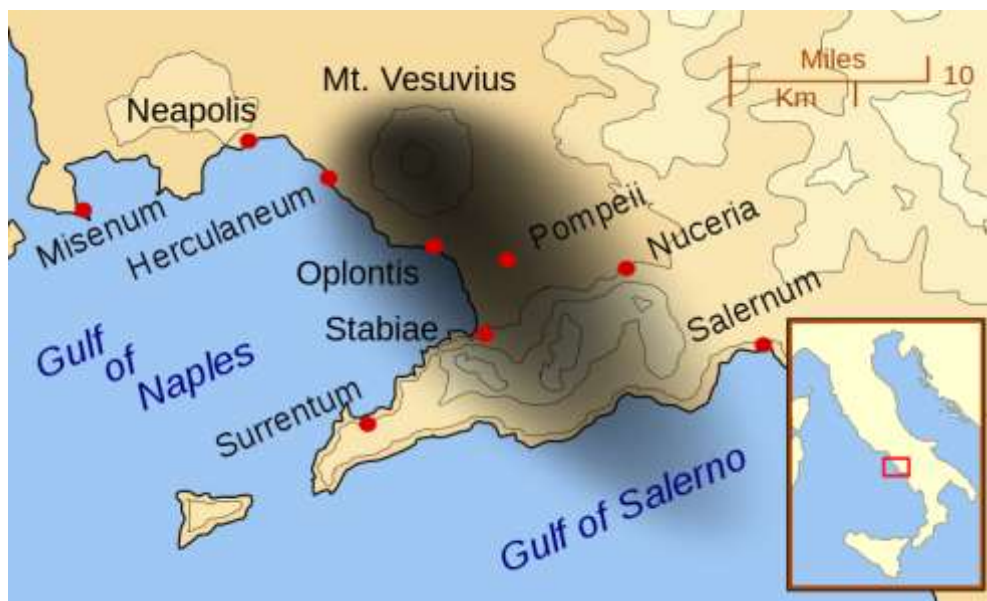
Figure 1: The Roman settlements affected by the eruption of Vesuvius in 79 CE. The black cloud represents the general distribution of ash and cinder. Modern coastlines are shown.

79 CE and the mountain, Vesuvius, erupted. The ash and other volcanic debris fell, poisonous gases overwhelmed the towns, and cities to the east and south east of the mountain (see Figure 1).

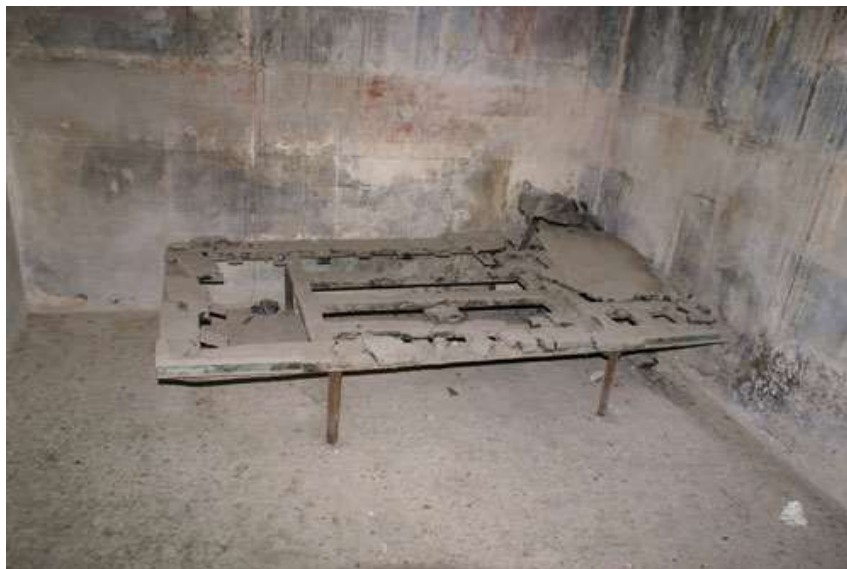
*Figure 3: A Roman bed found in the ruins of a villa in Herculaneum
Ministero dei beni e delle Attività Culturali e del Turismo – Soprintendenza special per
Pompei, Ercolano e Stabia*

Organic features such as wooden beams and furniture, and upper floors in many houses can be seen. The problem for conservers is that wooden material is particularly fragile, putting the site in constant danger of disintegration. This means that sustained efforts must be made to conserve the wood if the town is to be studied see Figure 3.

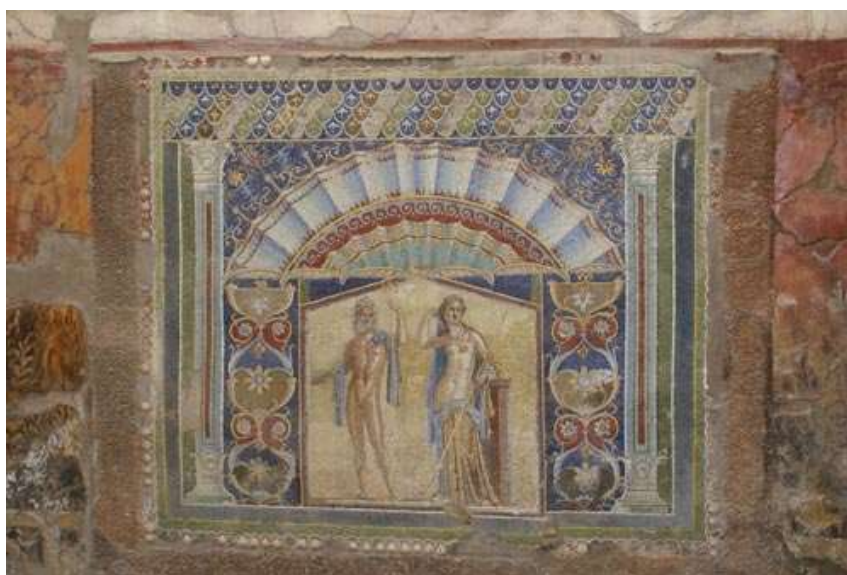
*Figure 4a: Example of a garden painting in Herculaneum
Ministero dei beni e delle Attività Culturali e del Turismo – Soprintendenza special per
Pompei, Ercolano e Stabia*

Once the wall has been protected the next task is to analyse the art from an historical viewpoint, and at the same time to estimate the current condition of the painting. Once that has been achieved the conservation takes place see examples in Figure 4a & b.
